After the FLOOD

With a little help from friends and neighbors, a Vermont homeowner restores her flood-damaged 1890s cottage once the waters subside.

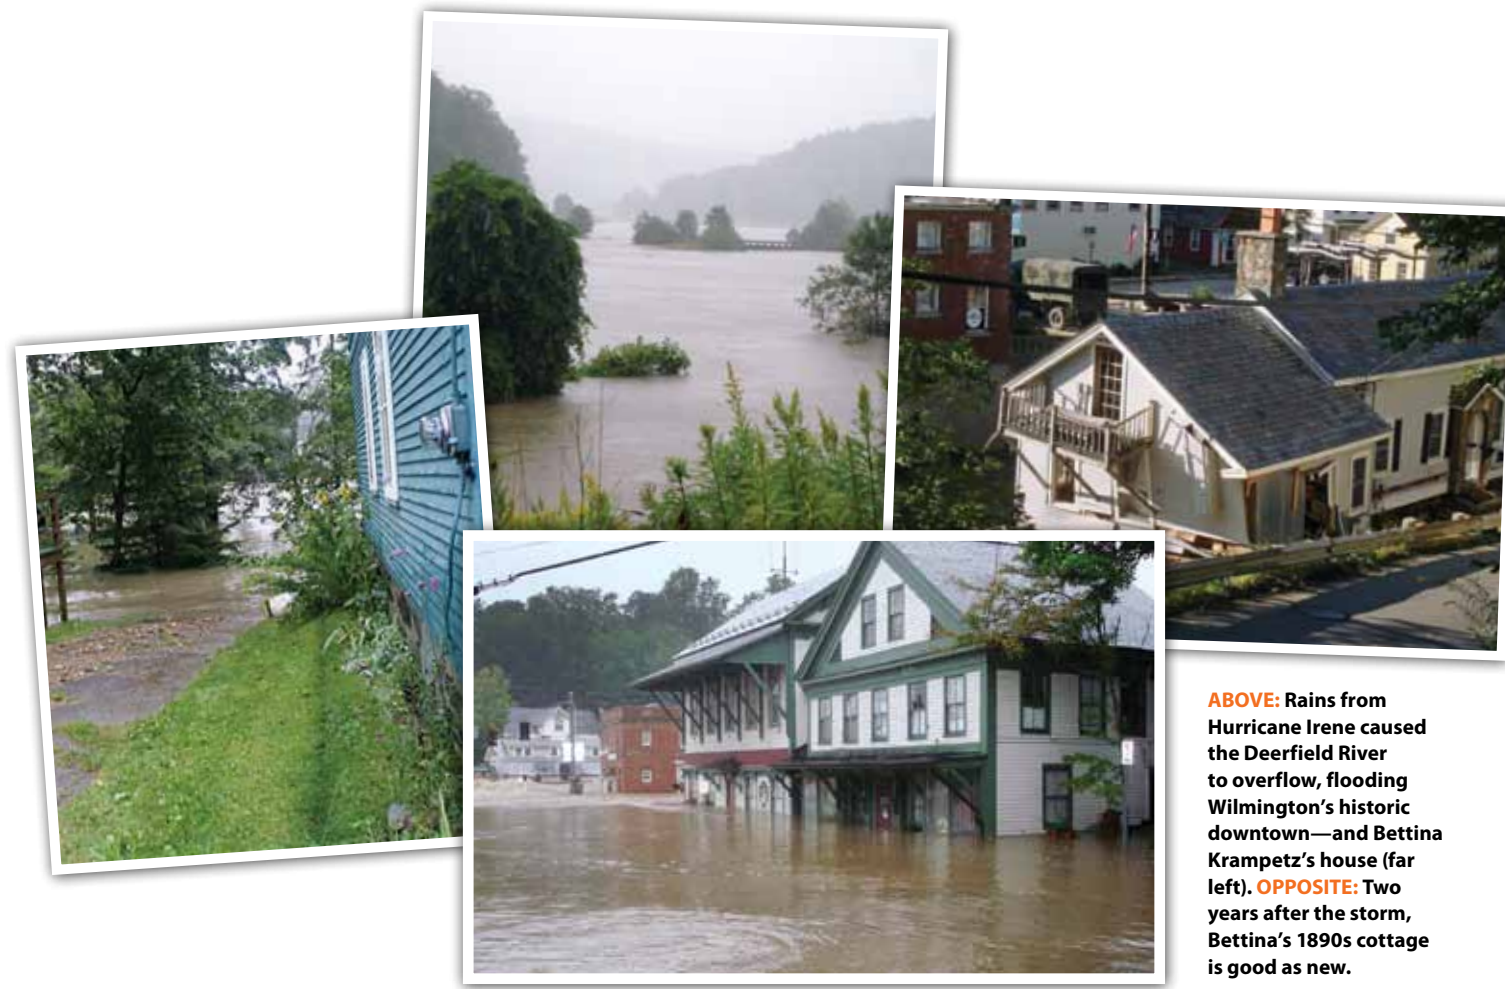
ABOVE: Rains from Hurricane Irene caused the Deerfield River to overflow, flooding Wilmington's historic downtown—and Bettina Krampetz's house (far left). **OPPOSITE:** Two years after the storm, Bettina's 1890s cottage is good as new.

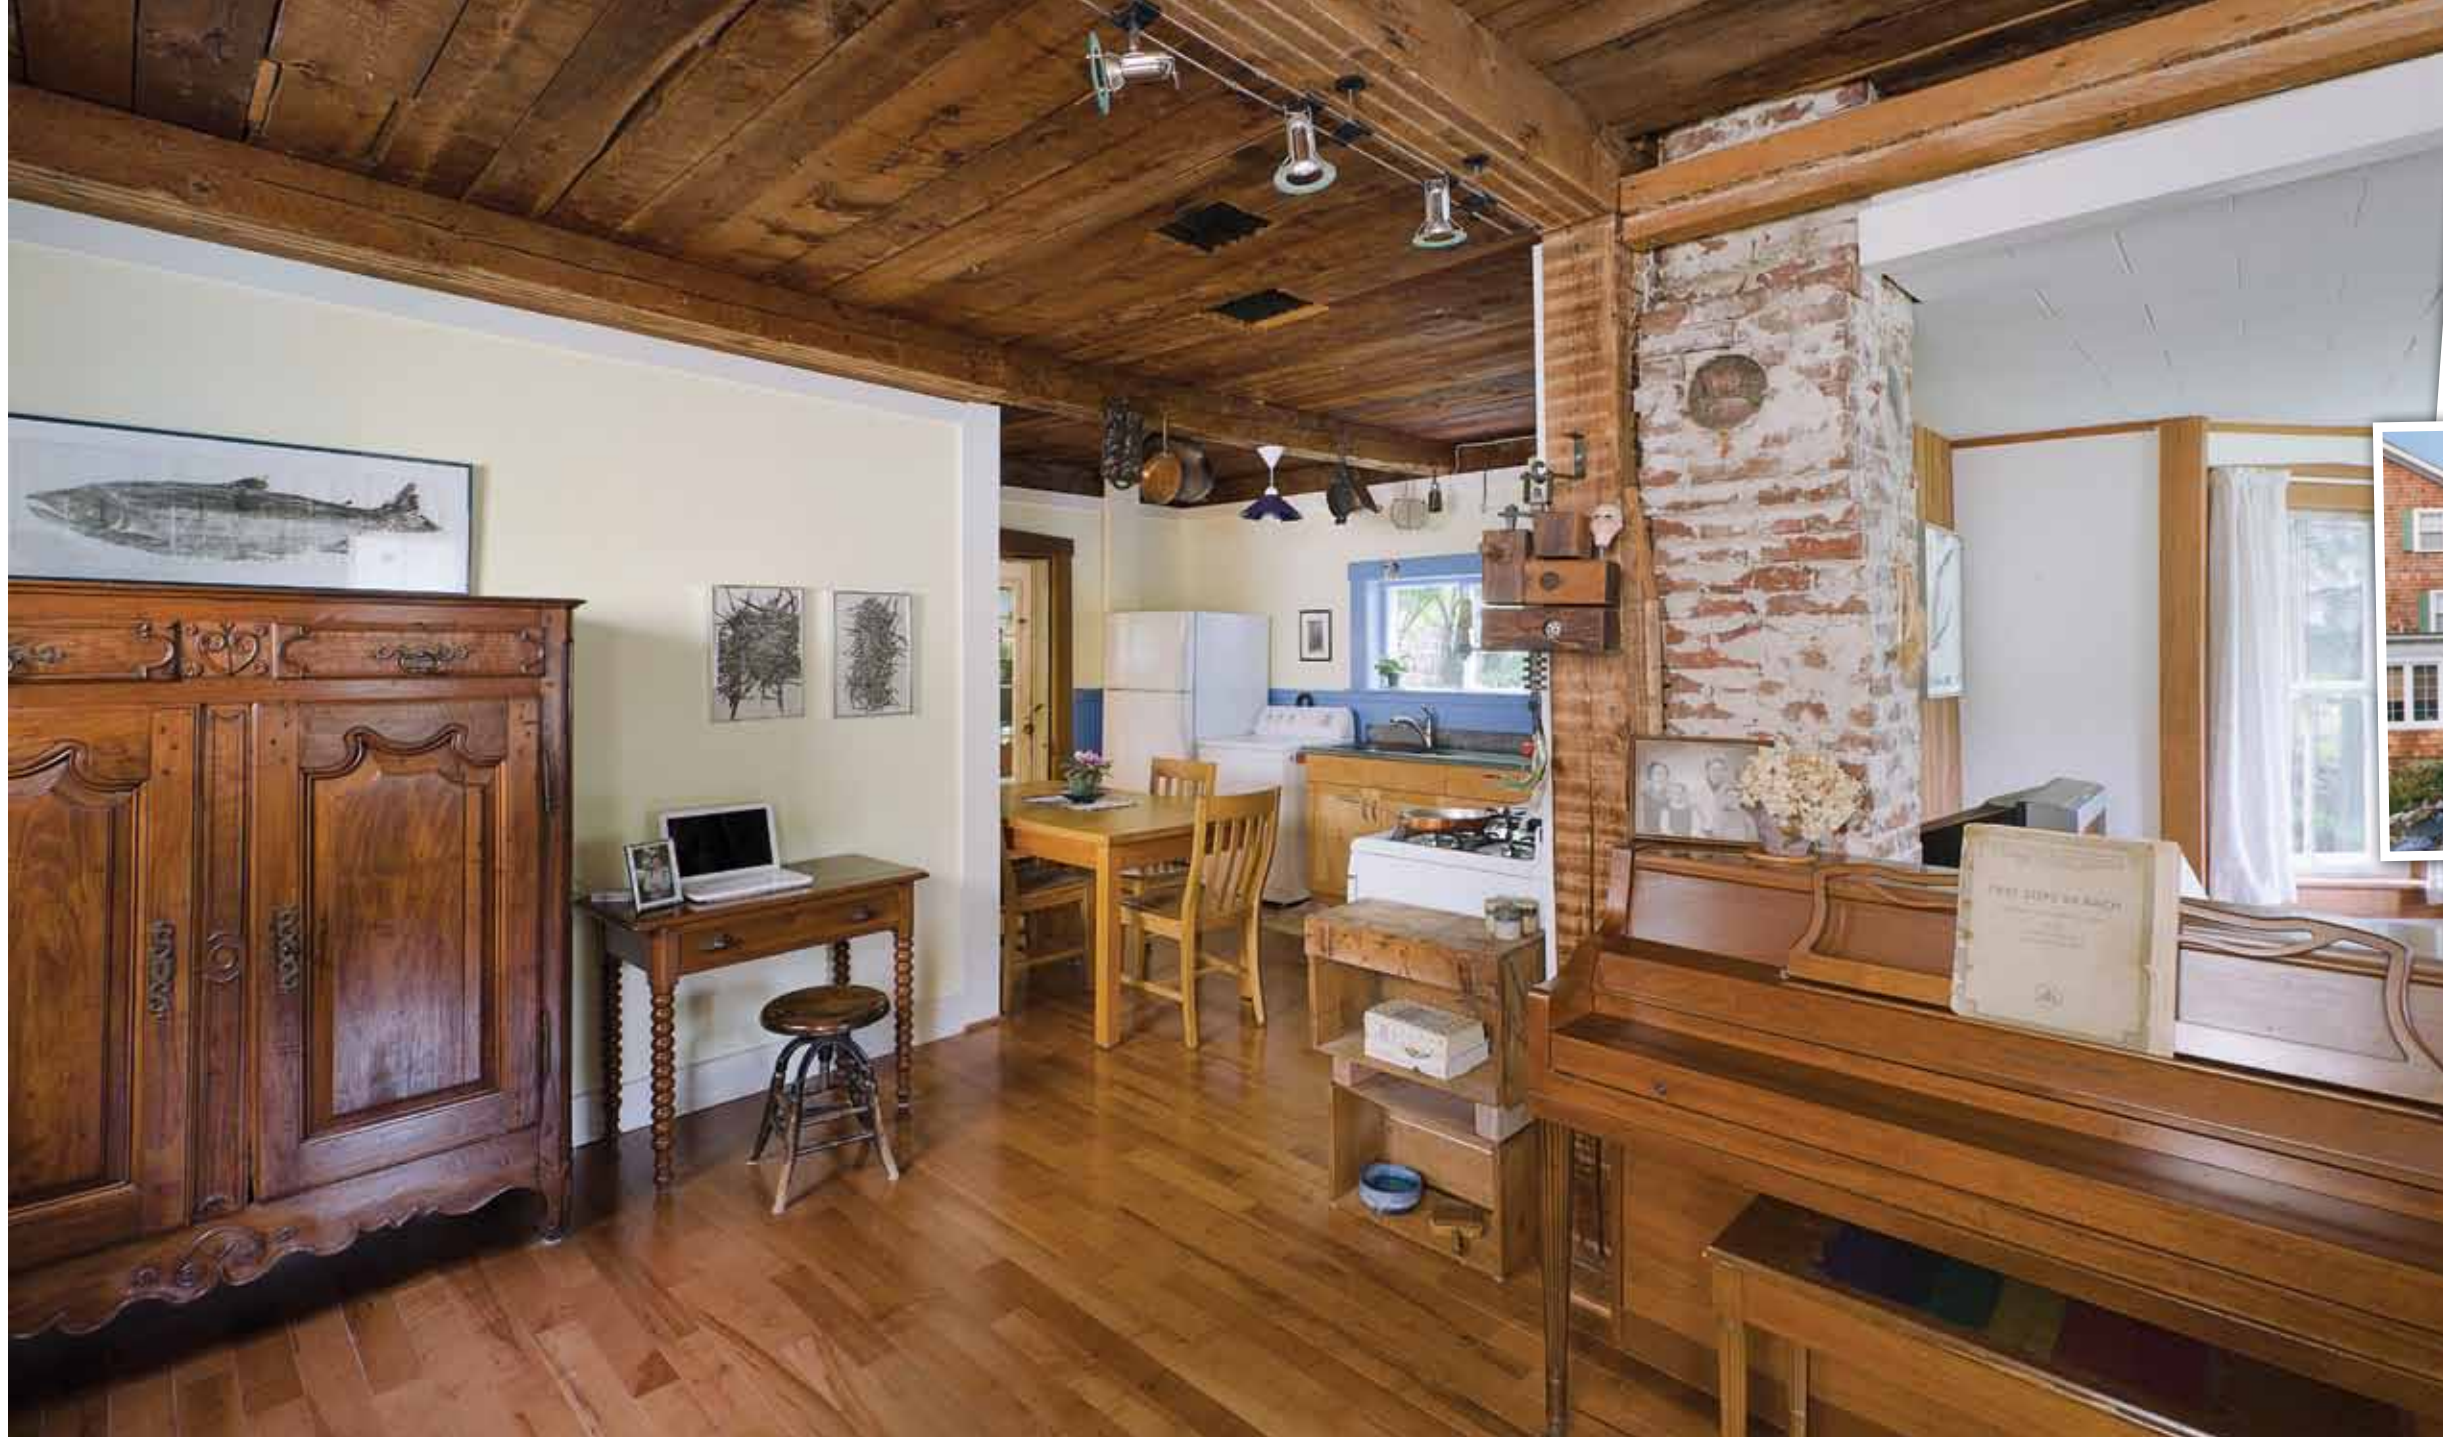
ABOVE: Bettina got a FEMA grant to help her restore the first floor of her house, which was inundated during the flood.

new space simple and as close to the original as possible," she notes. With the floors gone, Eric noticed that the original subflooring was sagging and installed support beams in the basement to lift it slightly. "If I jacked up the flooring too much, the house could potentially become unstable, and the plaster walls could crumble," he notes.

With the subfloor fixed, the next project was to install new flooring. "We wanted to make the floor as level as possible—something difficult to do in an old house," says Eric. "It took us two weeks just to frame and shim." Once the framing was in place, his team put down a ¾"

plywood subfloor and then the maple flooring. "We had to go back and trim the door bottoms to accommodate the ¾" rise," says Eric.

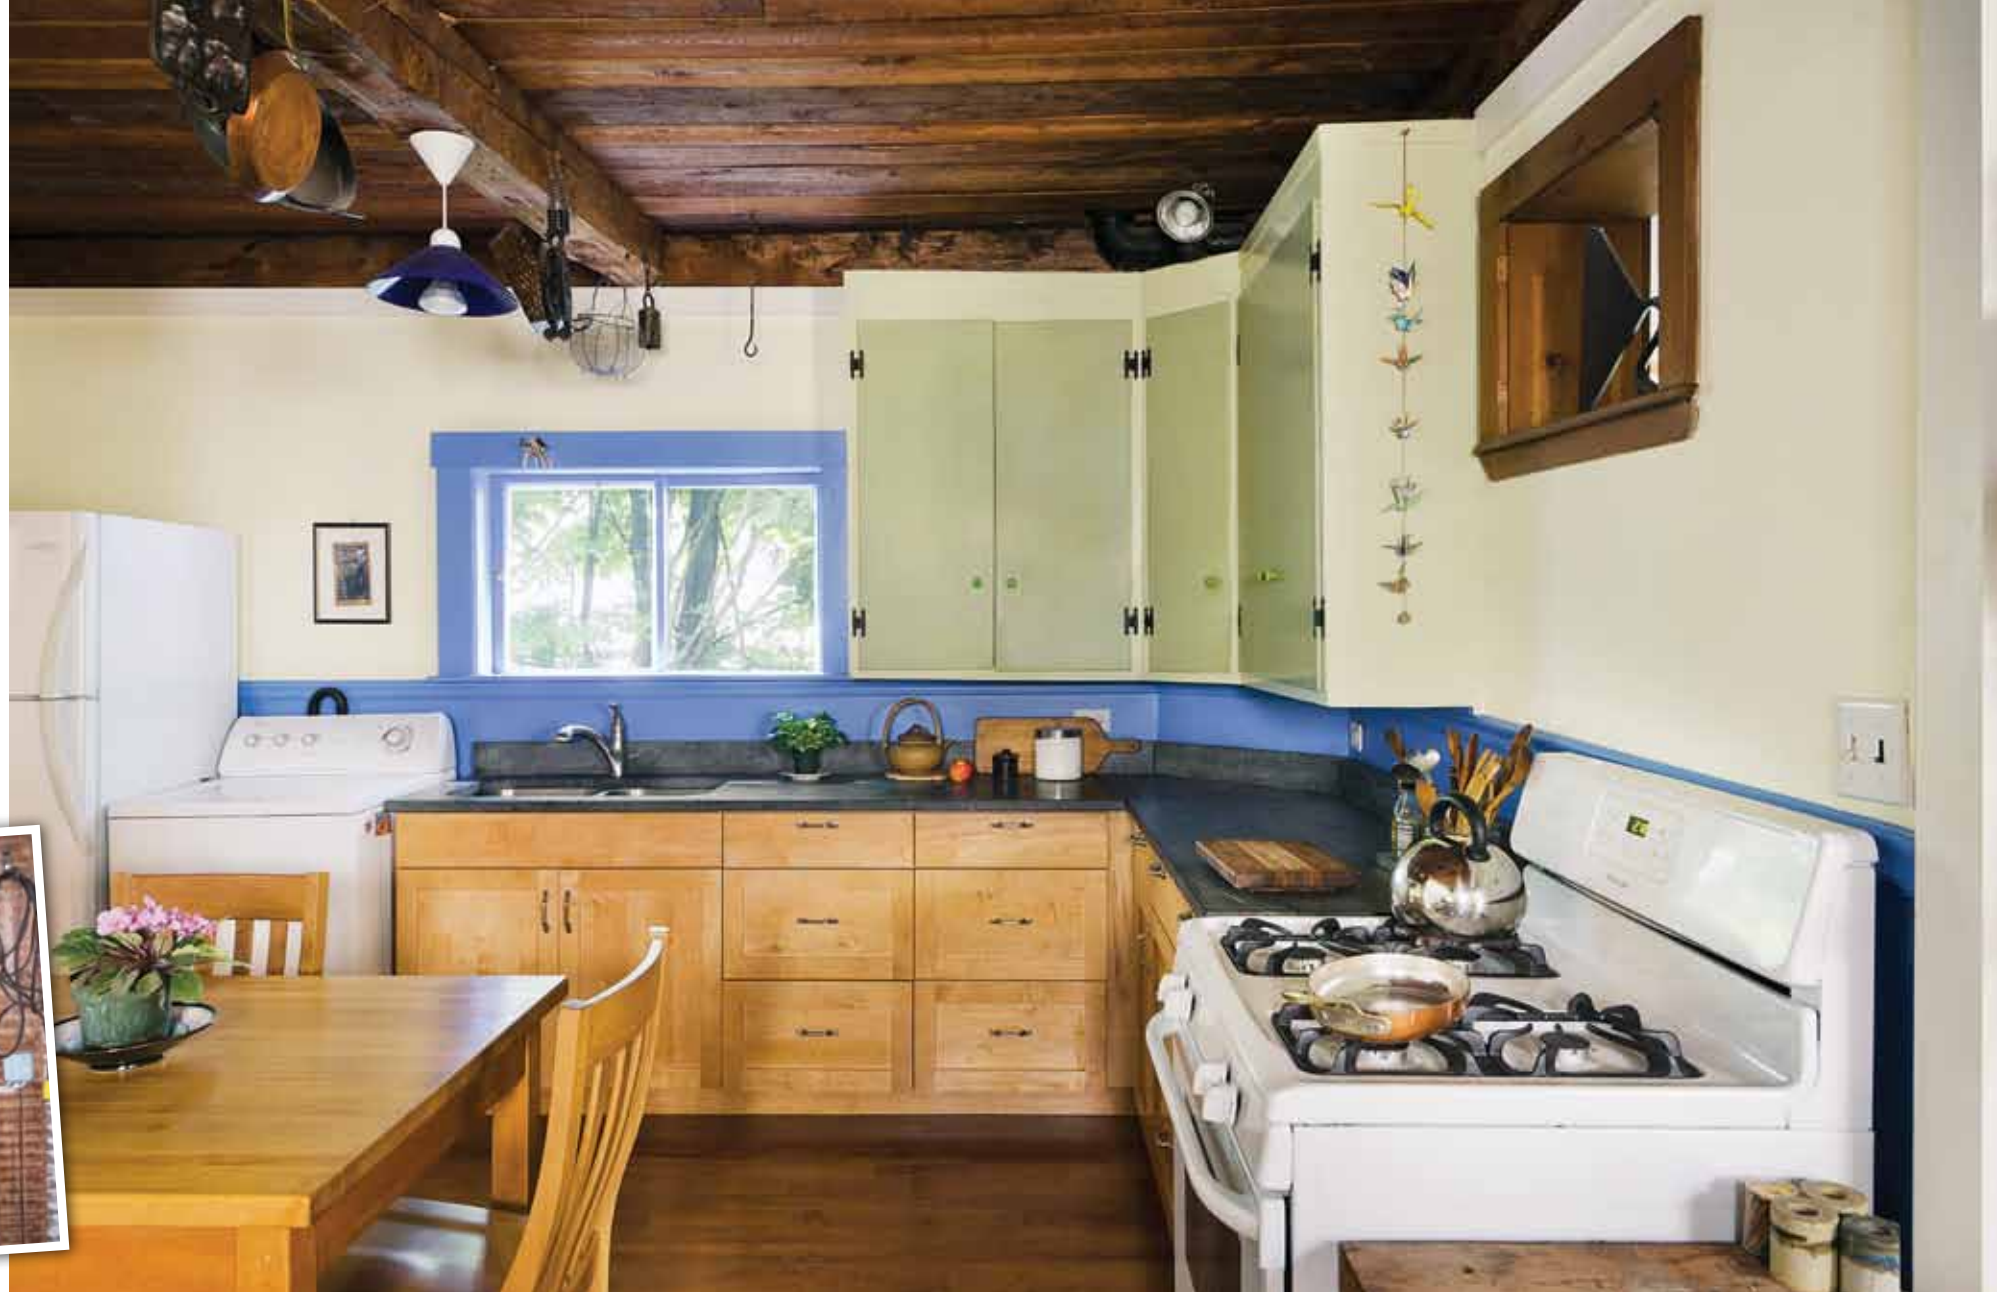
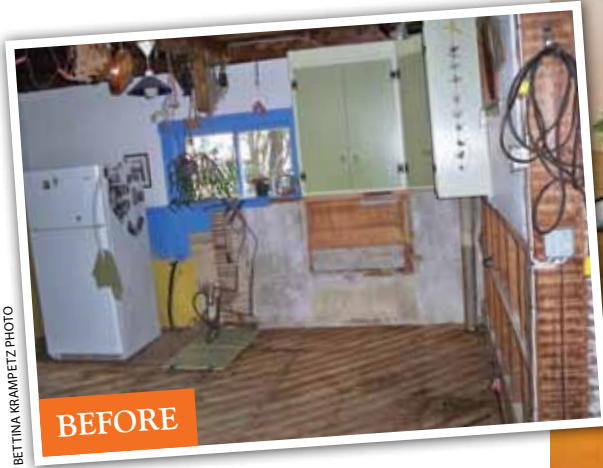
LEFT & INSET: Floodwaters damaged the kitchen cabinets beyond repair; new stock cabinets and a soapstone countertop were cost-effective replacements. **TOP:** Salvageable elements of the kitchen cabinets were repurposed in the bathroom. **ABOVE:** New maple flooring was installed throughout the first floor.

Next, he added insulation and drywall to the kitchen's outer wall, behind the lower cabinets, where none had existed before. He then installed modest stock cabinets and a soapstone countertop. Meanwhile, the first-floor bathroom received a new linoleum floor, the house was rewired, and a new water heater was installed. The oil tank had taken on water and had to be emptied and dried before being refitted. The downstairs received a fresh
